“SLIPPERY”

Issues in Aquarium Fire Losses

By Peter A. Lynch¹ and Chris Bloom²

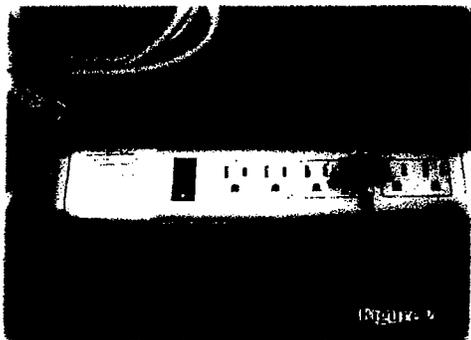
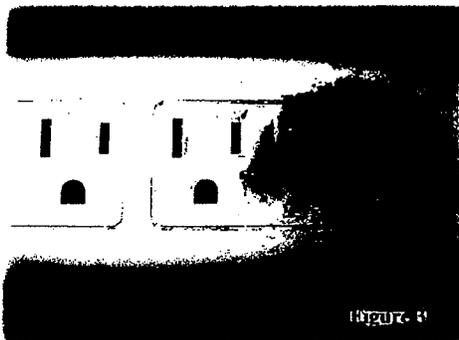
Closer examination of the fire damaged outlet strip noted that it consisted of six (6) receptacle locations. The fire damage was at the fourth receptacle from the switch end of the strip. It was apparent that no appliance cord had been plugged into the receptacle location where the fire damage had occurred. The case of the outlet strip showed no other evidence of heat or fire damage (see Figures 2 through 4).

The fire damage to the outlet strip clearly originated on the plastic face of the receptacle. There was no appliance plugged into this receptacle location at the time of the

fire. Thus, a problem related to an appliance power cord, or a high resistance connection between the plug and receptacle could be eliminated as possible causes of the fire. The mechanism for the fire clearly had to be some form of resistance heating across the face of the receptacle. The presence of salt crystals on the housing indicated that the most probable scenario was an accumulation of salt crystals creating a resistive path between the hot and neutral locations of the receptacle. This led to resistive heating that charred the plastic housing.

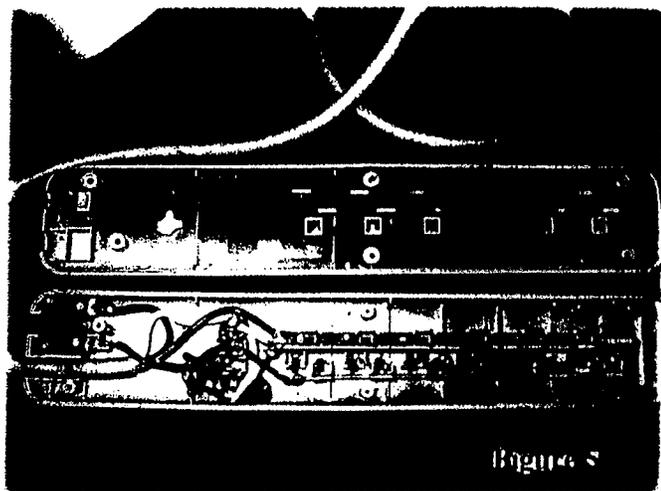
The housing for the outlet strip was taken apart. There was some smoke exposure to the interior of the housing, but no direct fire damage was noted on the interior portions of the plastic housing. The metal receptacle rails were intact (see Figure 5).

Both outlet strips were sent to microscopic and SEM analysis. On the undamaged outlet strips, it was determined that the deposits noted on the receptacle rails were salt crystals. On the fire damaged strip, the deposits noted on the receptacle rails were copper oxide, most probably a result of the fire. No salt crystals were found on the interior of the strip. Salt crystals were found, however, on the exterior of the outlet strip, particularly in the vicinity of the fire damaged receptacle location.

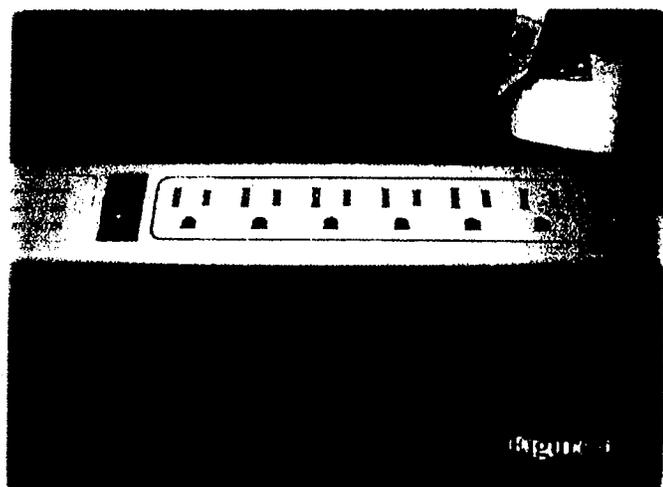
The second outlet strip was then examined. It appeared unremarkable from the exterior. Upon taking apart the housing, deposits were noted on the receptacle rail. (see Figure 6).
