Joseph M. LISIECKI, Charles A. WENSLEY, Peter D. LAYSON

Applications Engineering Group, Inc., Atlantic Beach, Florida

This article has the goal of empirically examining CSST breaches to determine whether electrically induced discharge damage can be differentiated from other causes of non-mechanical breaches, such as corrosion, and what impact this testing has upon the current state of investigation and litigation related to this product. Most recently, Applications Engineering Group, Inc. (AEGI) has conducted research to find indicators which could objectively differentiate electrically induced discharge damage in CSST from corrosion produced pitting perforations. Electrically induced discharge damage is a potential source of gas release, while corrosion produced holes are often a result from environmental corrosion caused after a fire.

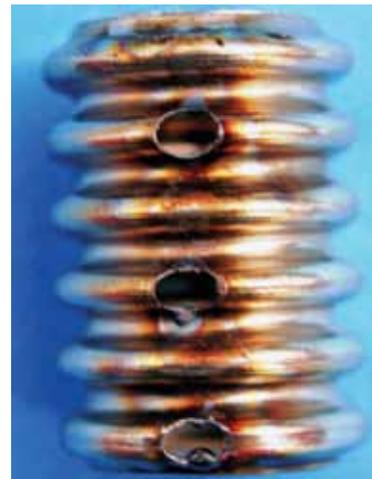
One common failure mode for CSST during a lightning strike is the transference of energy between CSST and another conductor at a different electrical potential, via an arc. Electrical arcing causes the melting and removal of material through the quick application of heat energy, known as ablation. Ablation, as it pertains to CSST, looks as if the hole was caused by melting, as manifested by a small bead raised above the metal surface surrounding the hole (Figure 2).

FIGURE 2
Ablation caused by electrical arcing.

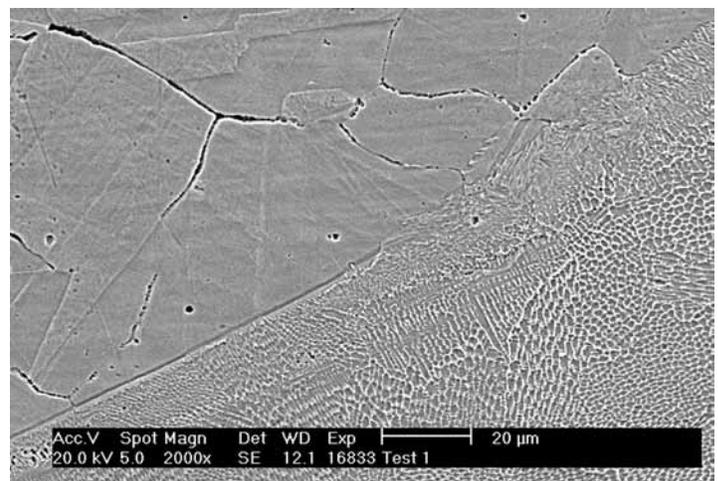
FIGURE 5
Normal equiaxed grains in CSST (upper left),
re-solidified CSST microstructure (lower right)

a non-equilibrium state containing extremely small finger like grains called dendrites. Areas which were not subjected to arc melting exhibited large equiaxed grains characteristic of the bulk material, and the re-solidified metal had a much smaller and elongated granular appearance. In Figure 5, the normal equiaxed grains appear on the upper left of the micrograph, and the re-solidified grains are on the lower right.

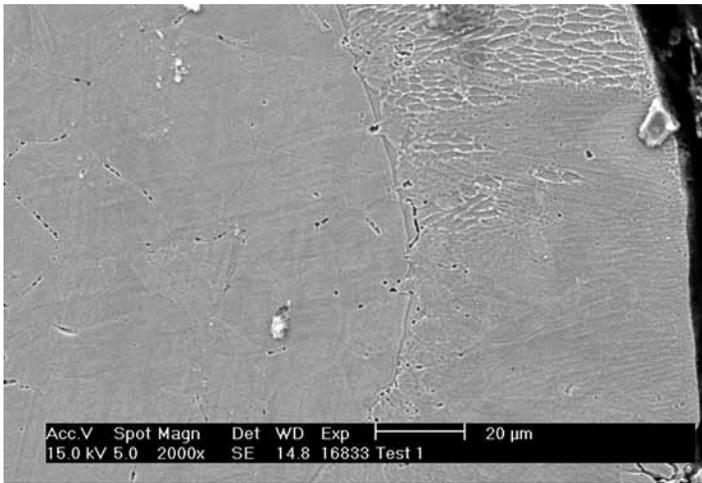
Several samples with electrical arc damage were exposed to *sensitization* temperatures of 1350 to 2000 degrees Fahrenheit (°F) (732 to 1093 degrees Celsius [°C]) for 2 hours. The ferritic/austenitic microstructure was easily visible in each of the sensitized samples after all six tested temperature exposures (Figures 6 and 7).

FIGURE 6
Sensitized CSST (1350 °F/732 °C)
Normal equiaxed grains in CSST (left),
re-solidified CSST microstructure (right)

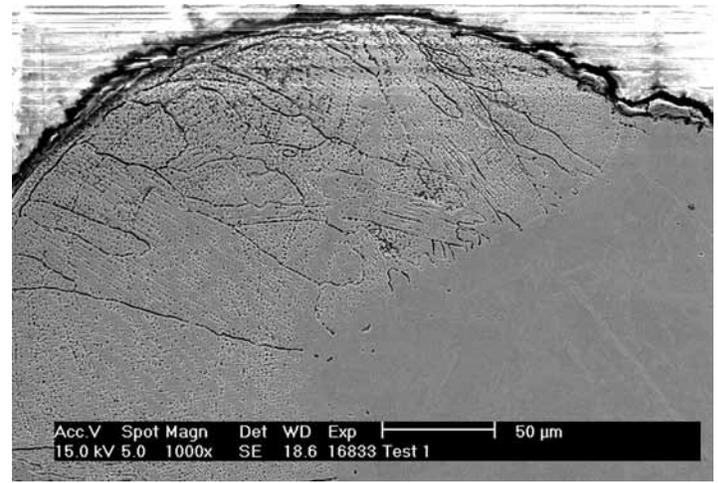
FIGURE 7
Sensitized CSST (2000 °F/1093°C)
Normal equiaxed grains in CSST (lower right),
re-solidified CSST microstructure (upper left)

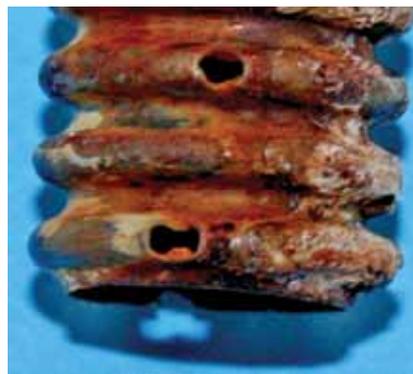
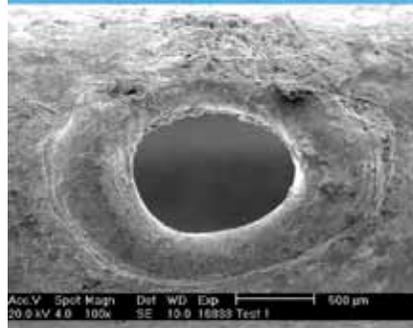
A second batch of samples were subjected to *sensitization* at 1200 °F (649 °C) for 8 hours, in order to initiate corrosion and simulate the observed rusting conditions in CSST after it has experienced a fire. In this corrosion study, the *sensitized* CSST samples were placed in an air-flow-confined corrosion chamber in a mixture of post-fire ground debris. Samples were corroded for 2 months while maintained in 100 percent humidity at 140 °F (60 °C). The observed corrosion mechanism in the CSST was pitting, and some of the pits developed into perforations that are consistent with the holes in CSST after being exposed to fire events. The corrosion induced holes had sharper and more jagged features than the electrically induced holes (Figures 8 and 9).

FIGURE 8
Electrically induced hole

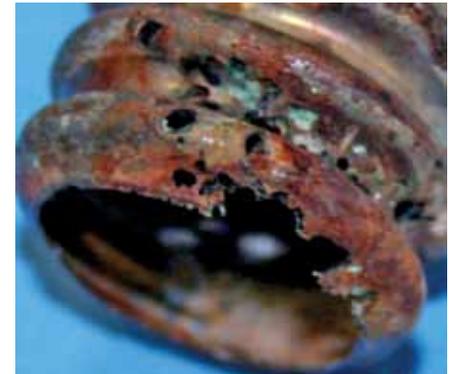
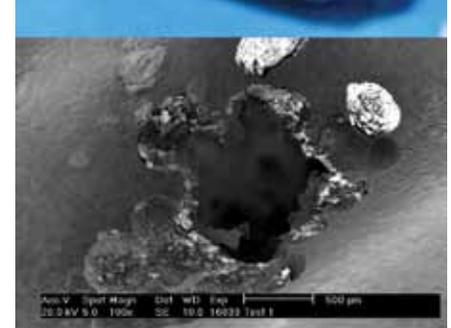
FIGURE 9
Corrosion induced hole

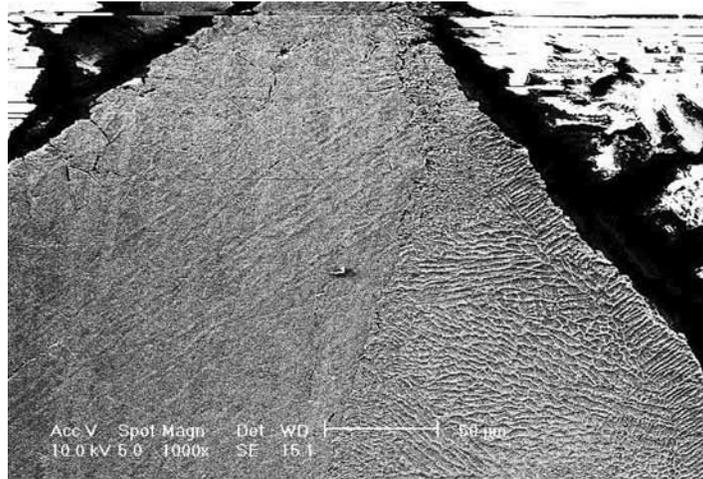
Microscopy showed little change in the appearance of the ferritic/austenitic microstructure at the known electrically induced failure sites, even after through-thickness pitting had occurred in the samples from corrosion (Figure 10).

FIGURE 10
SEM micrograph of electrically induced hole after corrosion exposure
Normal equiaxed grains in CSST (left),
re-solidified CSST microstructure (right)
