Flash, Kaboom! Water Heater Failures Involving GACs

Angela M. Hahn • 214.462.3015 • ahahn@cozen.com

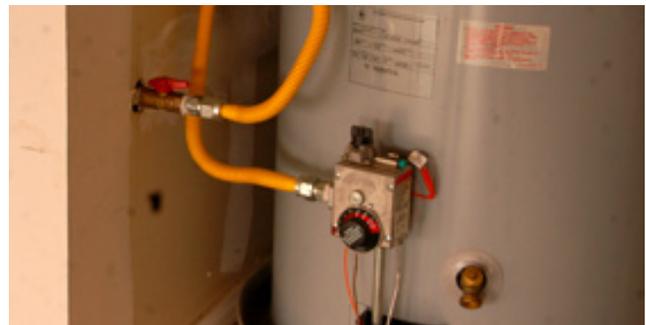
Photo 1 – yellow GAC feeding water heater

Similar to CSST, Gas Appliances Connectors (GACs) are pre-fabricated, similar in appearance and construction to CSST, with shorter runs. GACs service gas appliances such as furnaces, stoves, and water heaters. Like CSST, GACs can be subject to failure when impacted by errant electricity. The electrical current may result from a lightning strike, a failed air conditioning compressor, or other electrical anomalies such as energized or floating neutrals. The typical failure mechanism is an electrical arc and 'blow out' of the flared end of the GAC (see photo 2).

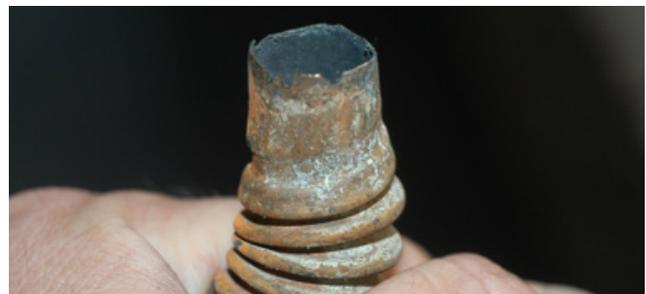
Photo 2- arced end of a failed GAC
