Joseph M. LISIECKI, Charles A. WENSLEY, Peter D. LAYSON

Applications Engineering Group, Inc., Atlantic Beach, Florida

This article has the goal of empirically examining CSST breaches to determine whether electrically induced discharge damage can be differentiated from other causes of non-mechanical breaches, such as corrosion, and what impact this testing has upon the current state of investigation and litigation related to this product. Most recently, Applications Engineering Group, Inc. (AEGI) has conducted research to find indicators which could objectively differentiate electrically induced discharge damage in CSST from corrosion produced pitting perforations. Electrically induced discharge damage is a potential source of gas release, while corrosion produced holes are often a result from environmental corrosion caused after a fire.

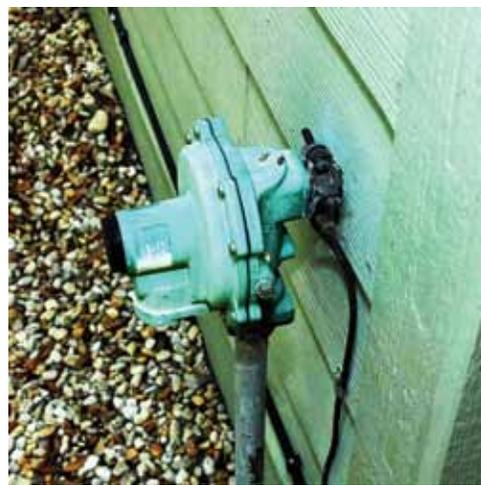
FIGURE 1
Bonding clamp attached to a gas regulator.

Bonding and grounding is the joining of CSST to the ground system in an attempt to dissipate unexpected electrical energy in the CSST. It can be accomplished by use of a third prong of a gas utilizing appliance with an electrical connection, or it can be done by the use of a bonding clamp and a grounding wire (Figure 1). However, CSST manufacturers no longer consider the use of a third prong a sufficient means of bonding their product.
